POLYCARBONATE WINDOWS

OPTIMAL SAFETY THROUGH
REGULAR REPLACEMENT

OPTIMAL SAFETY IN THE EVENT OF A MACHINE CRASH

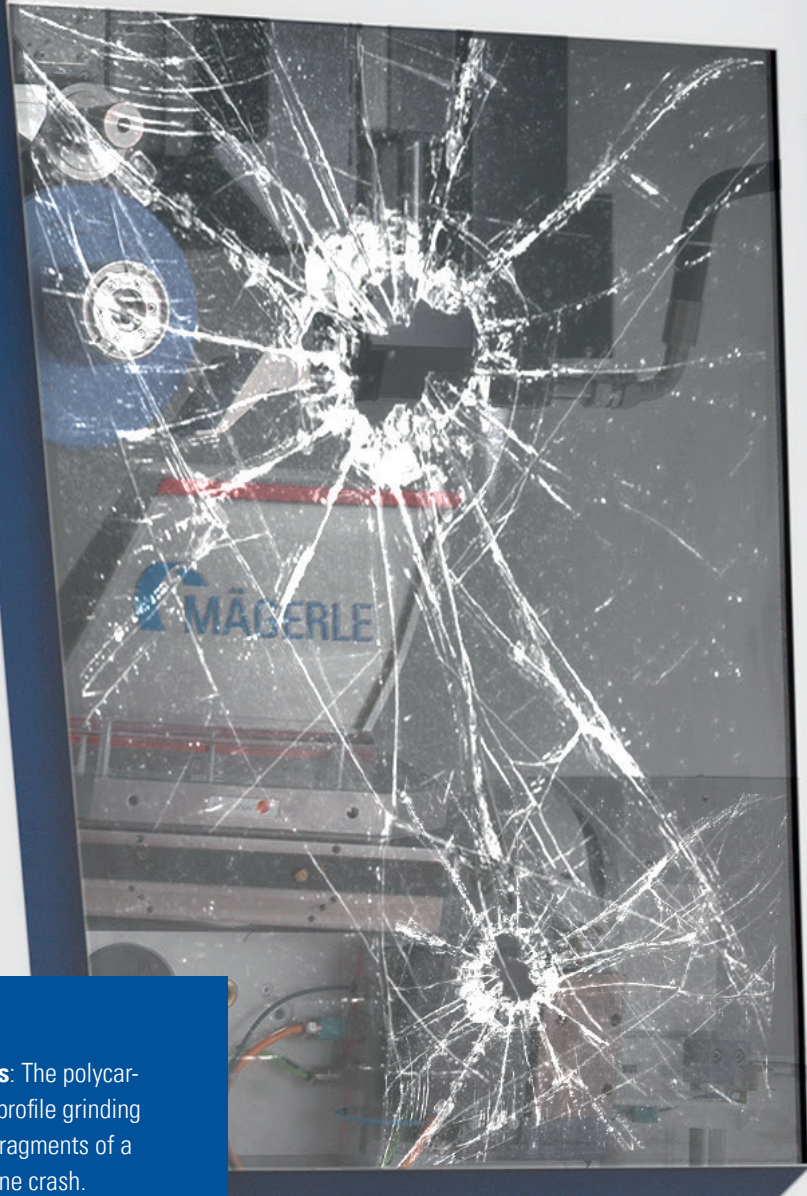
Protected thanks to polycarbonate windows: The polycarbonate windows on your MÄGERLE surface and profile grinding machine protect the machine operator from the fragments of a shattered grinding wheel in the event of a machine crash.

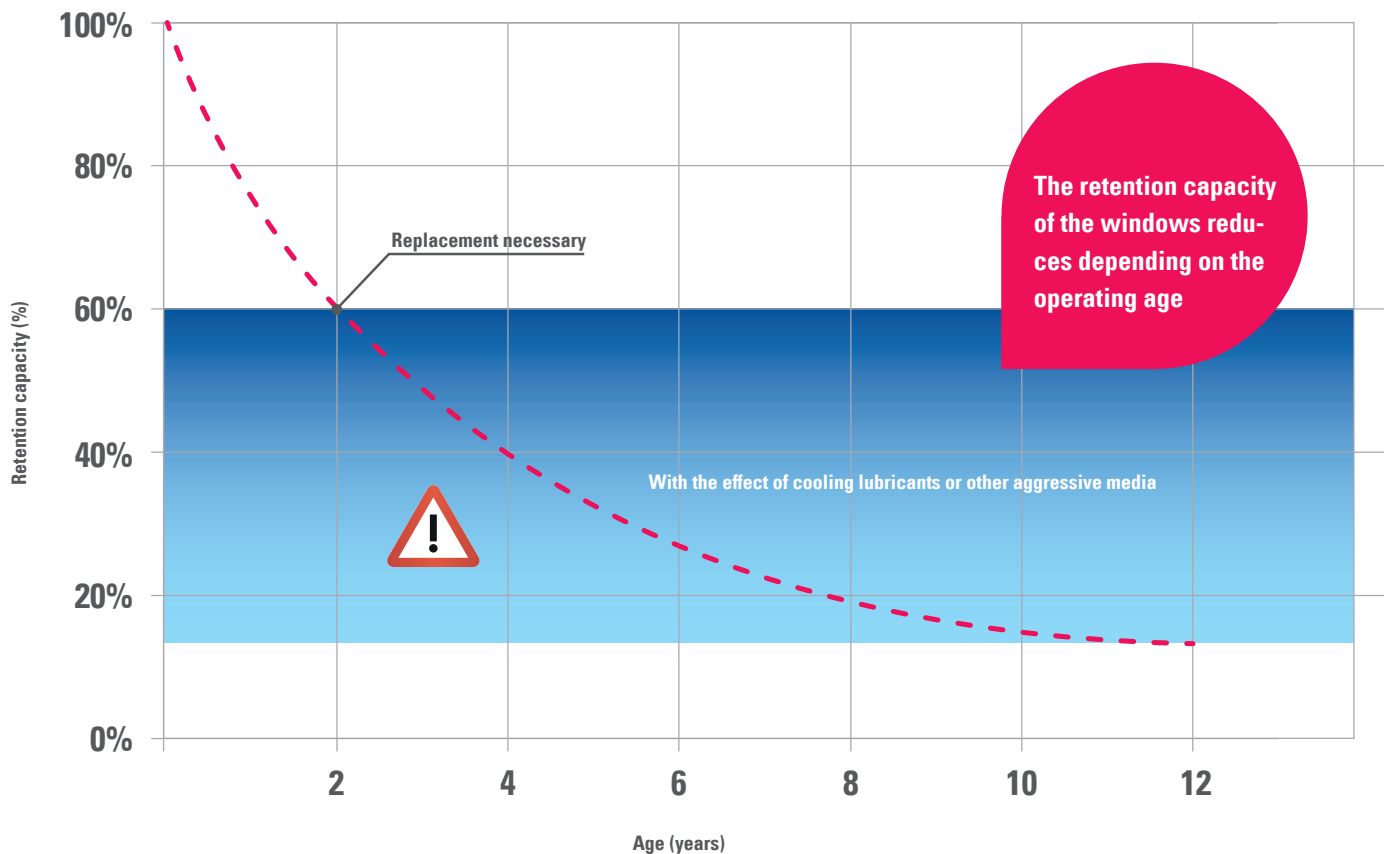
AGEING OF POLYCARBONATE WINDOWS IN MACHINE TOOLS

The use of coolants, oils and greases reduces the working life of your polycarbonate windows. They encourage porosity and thus reduce the retention capacity under mechanical impact. This embrittlement is generally not visible to the eye, but as the operating life increases, presents a significant safety risk for machine operators.

For optimal safety European safety standard EN 13218 recommends replacing the polycarbonate windows every two years. Therefore please check the age of the windows on your MÄGERLE grinding machine. In the case of visible cracks, scratches or the visible penetration of cooling lubricants, the windows must be replaced immediately.
